DIRECTORATE OF FLYING SAFETY - ADF

**DFS-ADF INCIDENT INVESTIGATION REPORT
10SQN ASOR 032/98**

**OCCURRENCE INVOLVING AN AIRBORNE CONFLICT BETWEEN ROYAL
AUSTRALIAN AIR FORCE P-3C ORION A9- 665 (CALLSIGN RESCUE 251) AND
AUSTRALIAN AERIAL PATROL CESSNA 402, REGISTRATION VH-PEH, EAST
OF BERMAGUI, NSW ON 28 DECEMBER 1998**

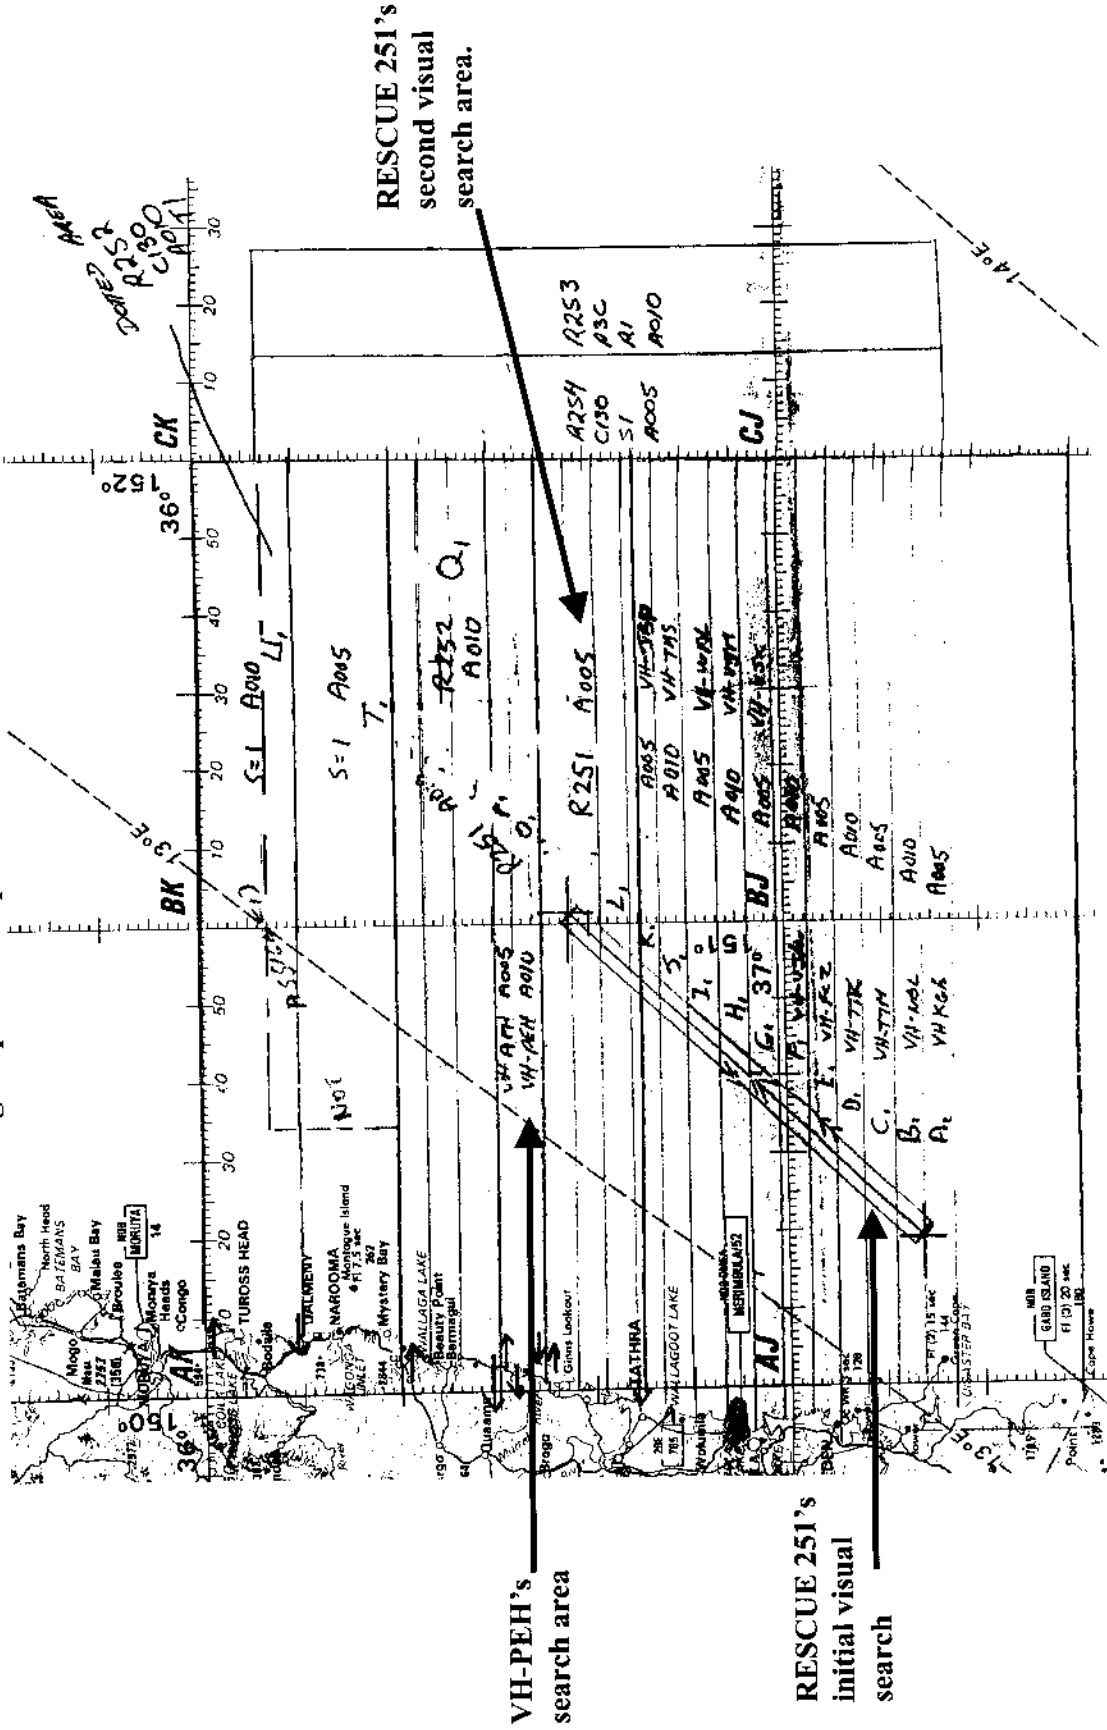
AusSAR Planning Map - Search plan for the 'Winston Churchill' 28 Dec 98.

- 1.8.4 With the initial search by RESCUE 251 proving unsuccessful, the SAR Coordinators subsequently planned a more extensive visual search from 36°03’S to 37°17’S from the southern NSW coast to 152°00’E, utilising 13 civil fixed wing aircraft, RESCUE 251 and a RAAF C-130 Hercules. Each aircraft was allocated a strip 3NM North-South and approximately 90NM East-West, stretching from the coast to 152°00’E. The areas were labelled ‘A1’, ‘B1’, ... to ‘L1’ (RESCUE 251) then ‘O1’ (VH-PEH), ‘P1’, ‘Q1’ and ‘T1’. There were no buffers between adjacent areas but search altitudes alternated between 500ft and 1,000ft to provide separation. In the search plan RESCUE 251 was assigned 500ft and VH-PEH 1,000ft. A photocopy of the search planning chart used by the SAR Coordinators is at Annex A.

- 1.8.7 In the case of the second re-tasking of RESCUE 251, the planning chart at Annex A includes the altitude assigned to RESCUE 251 (500ft) plus information on adjoining aircraft. The handwritten note of the re-tasking, logged at 0648, omits the altitude assignment but contains information on adjacent aircraft, including VH-PEH. The telephone message from AusSAR to Melbourne FIS, which was recorded at Melbourne FIS, did not include the altitude assignment or any information on adjacent aircraft. Melbourne FIS correctly relayed the telephone message received from AusSAR to RESCUE 251 over the radio.

RESQ 251's second visual search area.

VH-PEH's search area
