DATE: 3 September 1999
MEMO TO: Sen. Const. David Upston
FROM: Warwick Hood
SUBJECT: "Business Post Naiad" - Removal of Internal Ballast

THE YACHT "BUSINESS POST NAIAD"

1998 SYDNEY - HOBART YACHT RACE

**A Report on Investigations into
Stability & Measurement Certificates**

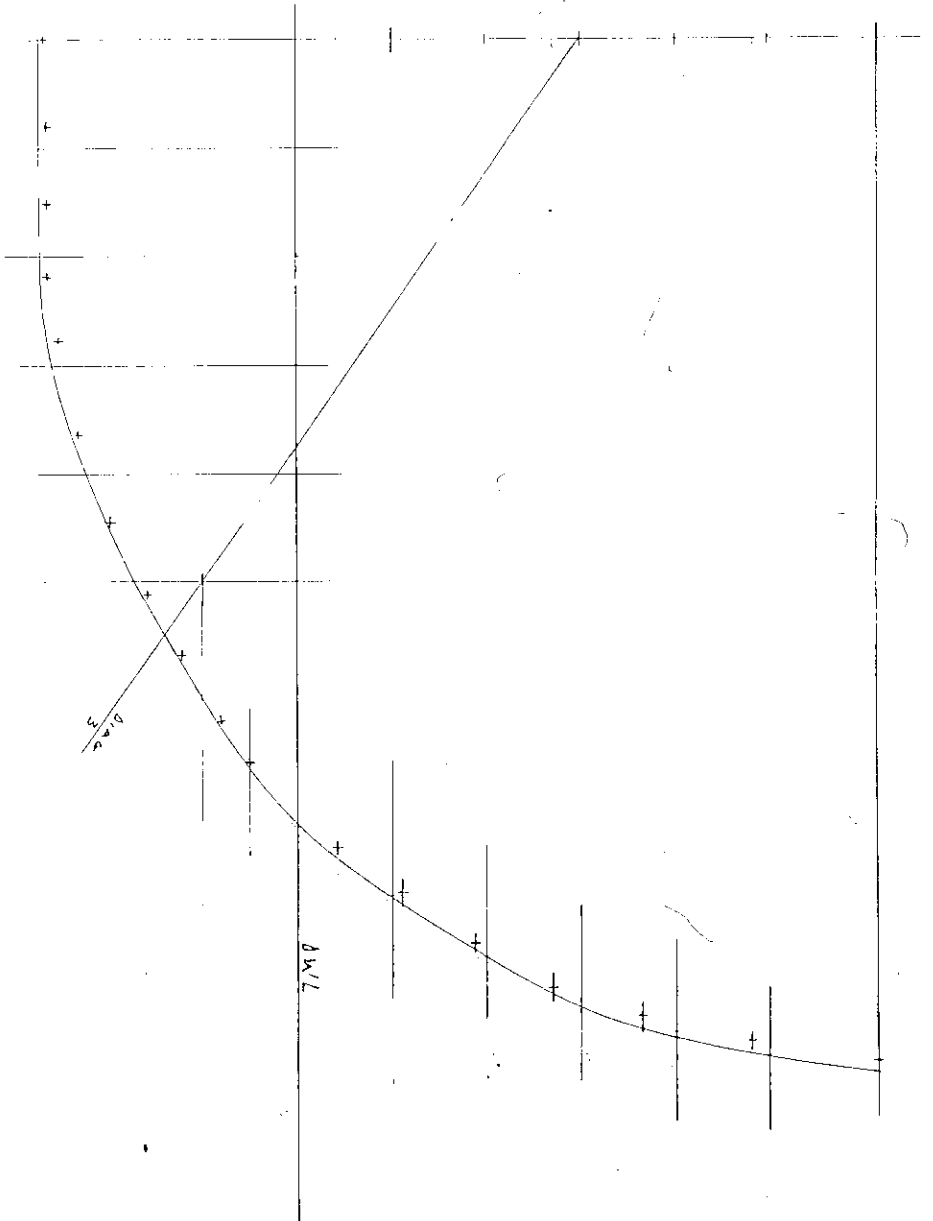
EXHIBIT 1

- 3.11 Exhibit 1 hereto shows a plot of the offsets for station 6 on the Sections & Offsets Plan No. 138/2A Station 6 is located 6.544 abaft the head of the stem and is the biggest station in terms of breadth of the waterline. Station 7 is a little bigger above the waterline.

- 3.12 Shown as dots only are the intersections of the yacht measurer's vertical and horizontal measurements taken from the file of offsets supplied by Mr Mooney for a station 6.403 metres abaft the head of the stem. This station is 143 millimetres forward of station 6 above.

- 3.13 The measurer's station is a little forward of the designer's station 6 and it should be a little smaller, as is indeed shown by the exhibit. The two sections shown have a good similarity.

- 3.14 The drawing indicates a number of other things as well. Note that:
- (a) the hull is slightly shallower than designed, and
 - (b) the measurer recognising that the bottom is designed to be flat from the centreline out to beyond the 420 buttock, has taken three measurements in this area.

- 3.15 It may also be noted that in defining this section near the designer's section 6, the measurer has taken 18 spots in comparison with the 21 provided by the designer. This is not, in a seriously deficient number. The writer is confident that the number given adequately describes the hull shape in the area of the hull in question to the computer.
- 3.16 Because the inverted (180° heel) stability is of importance, the writer has calculated the change in the vertical centre of gravity of the yacht with its broken mast and rigging secured on its deck - see Section 5 and with this knowledge, the stability inverted - see Section 6.
- 3.17 There appears various anomalies in the measurement certificates available. The writer has spent some time in the examination of these certificates, especially in connection with the yacht's internal ballast. These are detailed in Section 7 hereof.

SOLID LINE FROM DESIGNER'S LINES PLAN
+ FROM MEASURER'S FILE
