SPECIAL REPORT : SR99/004

Research and Development test of yachting safety products

Client : NSW Police Service
NSW Water Police Branch,
Wharf 25
Harris Street
PYRMONT NSW 2009.

One (1) Yachting line involved in fatal incident,
from the 'Sword of Orion' yacht.

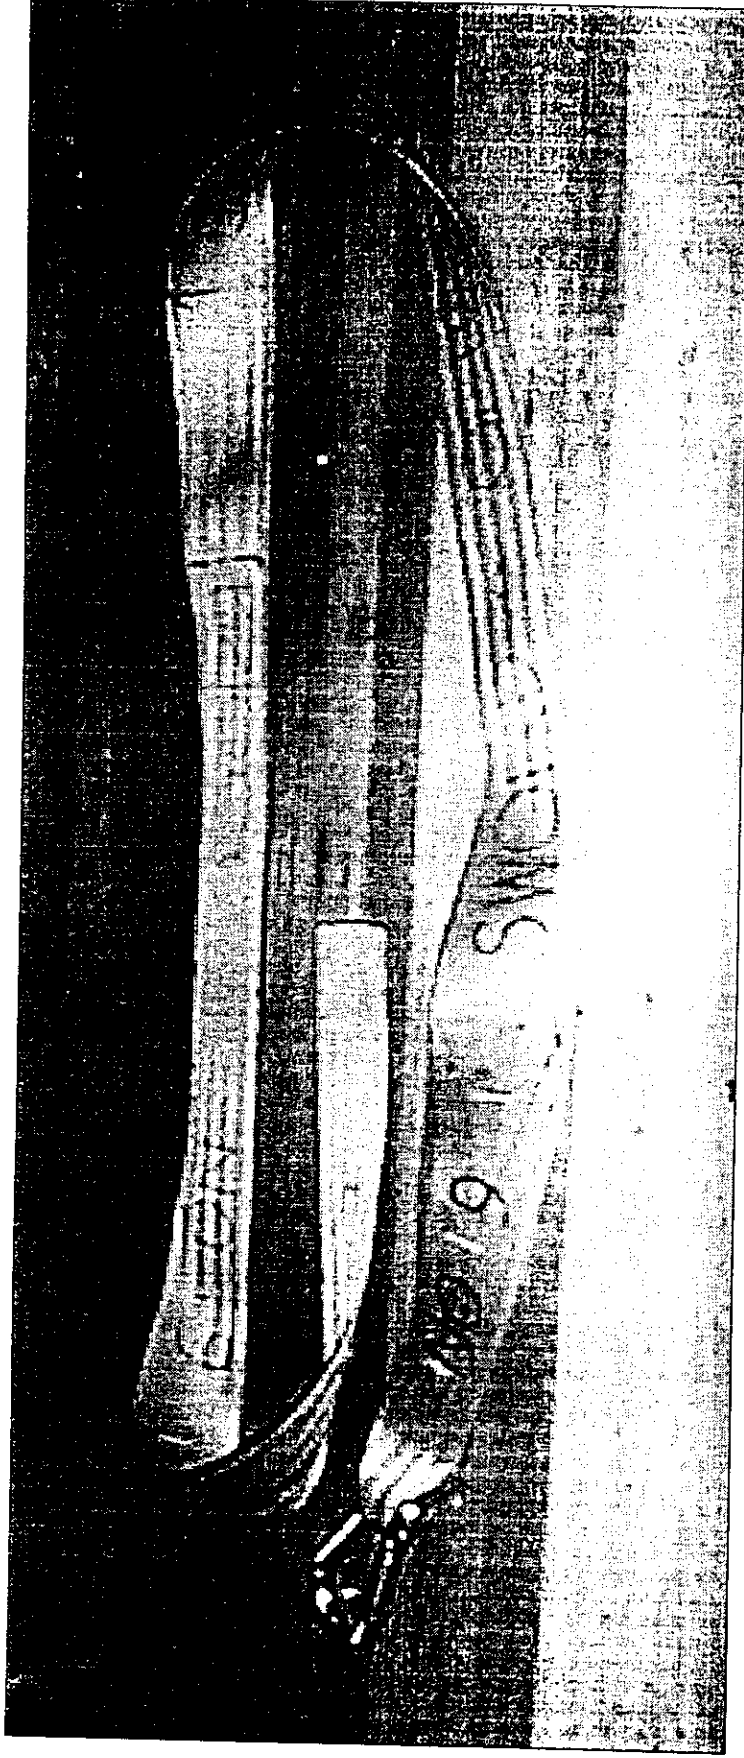
The yachting line was supplied with only the anchorage attachment hook intact. The yachting line stitch pattern at the harness attachment end failed and consequently the other attachment hook and harness were not recovered.

The stitch pattern on the harness attachment end failed completely, the main red stitch pattern, which was approximately 200 mm long by 40 mm wide, had all stitches completely torn. The three small reinforcing yellow stitch patterns approximately 15 mm long by 2 mm wide, equally spaced out between the main stitch pattern, also had all stitches completely torn.

The stitch pattern on the anchorage attachment end had approximately fifty percent of the main red stitch pattern torn and one of the small reinforcing yellow stitch patterns also had all stitches torn. The single action hook was distorted and deformed at the swivelling pin, it remained in the open position and did not function properly. Refer to Photograph 1 in Appendix B.

The visual assessment on the yachting line involved in the fatal incident revealed that the extent of failure of the stitch patterns at both ends of the line was severe. The harness attachment end had complete stitching failure and on the anchorage attachment end fifty percent stitching failure.

Photograph 1 - Yachting line involved in fatal incident with only one attachment hook still intact.

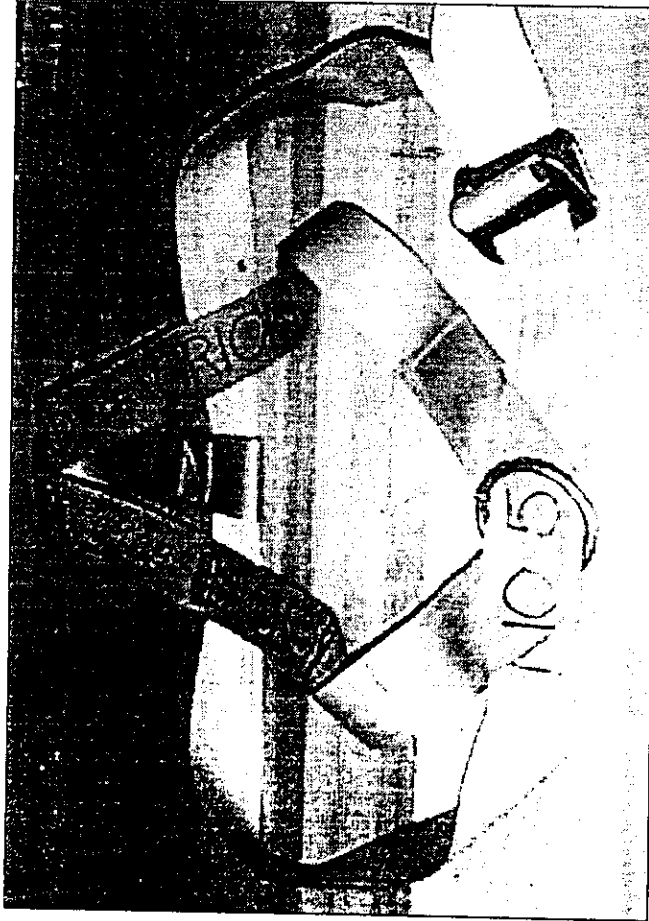
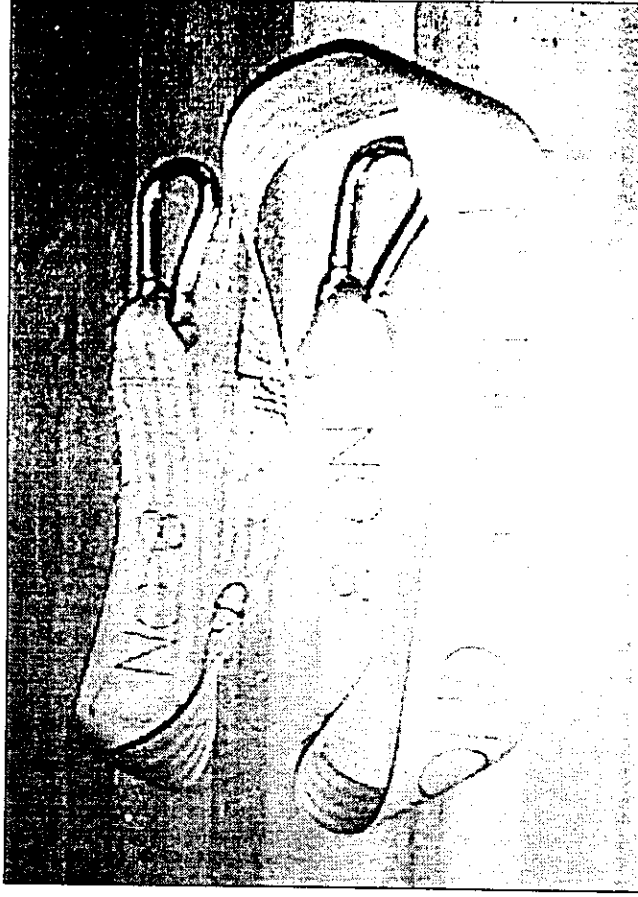
Photographs 2 & 3 - Yachting harness and line assembly supplied for the comparative test program.

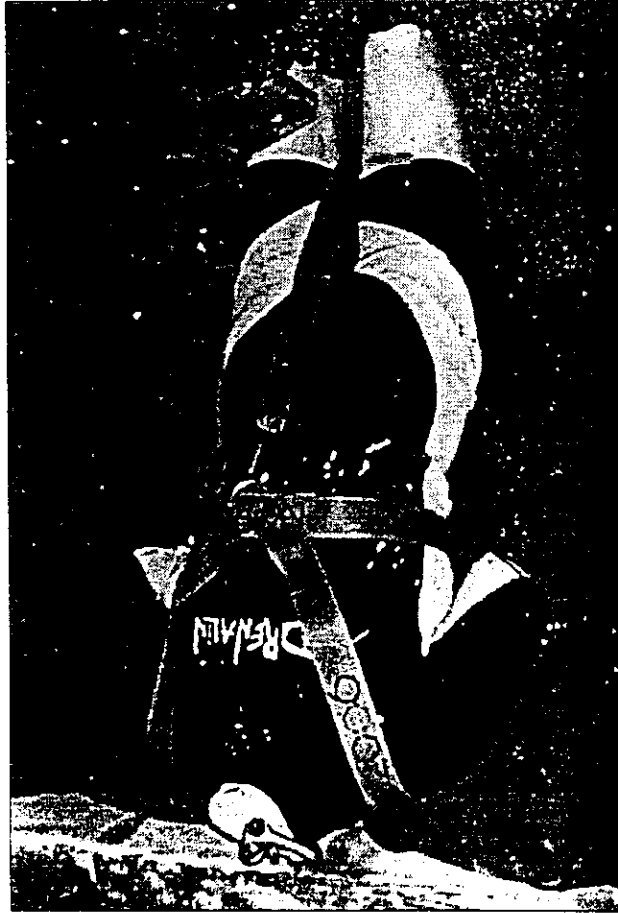
The harness attachment end stitch pattern had approximately fifty percent of the main red stitch pattern torn and one of the small reinforcing yellow stitch patterns also had all stitches torn. The 'O' ring attachment point was significantly distorted and deformed. Refer to Photographs 10 to 12 in Appendix B.

Photographs 10 & 11 - Post test views at base of harness drop tower showing the test dummy not retained and torn stitch pattern of yachting line at harness attachment end.

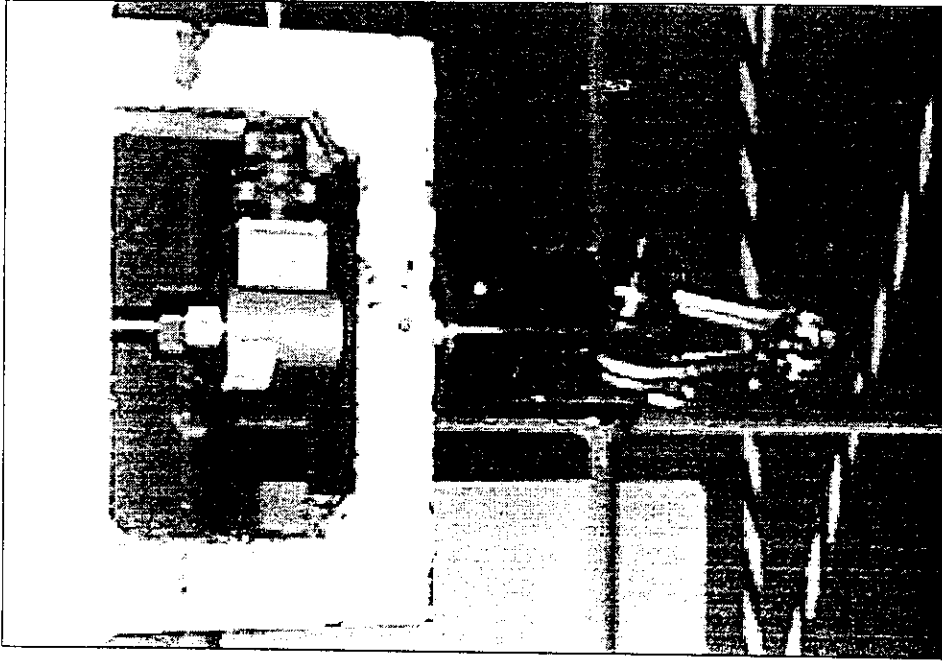
Post test examination of the Test Run Number IH9025 on the complete yachting harness and line assembly revealed that the anchorage attachment end stitch pattern failed completely at 6.7 kN. The test dummy was not retained and only the hook was left at the harness anchorage point. Refer to Photograph 8 in Appendix B.

The anchorage attachment end stitch pattern which was approximately 200 mm long by 40 mm wide and the three small reinforcing yellow stitch patterns approximately 15 mm long by 2 mm wide, equally spaced out between the main stitch pattern had all stitches completely torn. Refer to Photograph 9 in Appendix B.

Assessment: Fail, Clause 7(a) and (b).

Clause 7(a) states, "the dummy shall be retained in the harness;".

Photographs 8 & 9 - Post test views of hook at anchorage point and completely torn stitch pattern of yachting line.

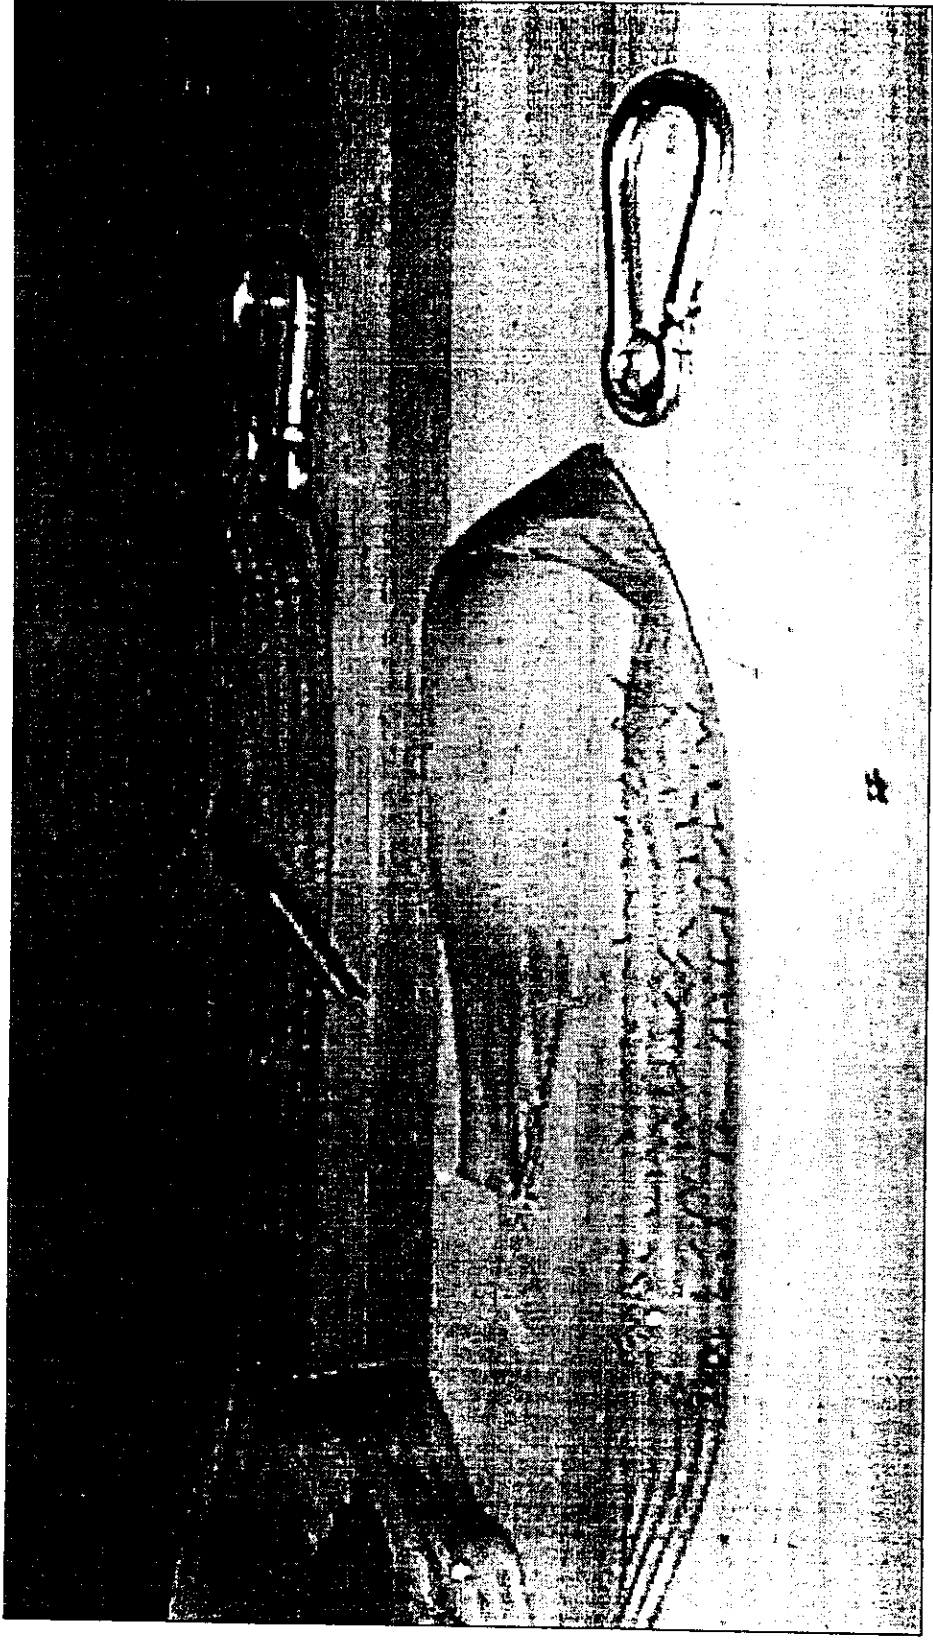
The results from the dynamic test indicate that the yachting harness and line assembly was subjected to similar loads as to the yachting line involved in the fatal incident because the extent of stitch pattern failure to both specimens was similar except that they occurred at opposite ends.

Clause 7(b) states, "no part of the harness or line shall fail or deform to such an extent as will render it incapable of performing its intended function;..."

Photograph 12 - Detailed post test view of yachting line with the same extent of stitch pattern failure as the yachting line involved in the fatal incident.
