# Issues Relating to Liferaft Operation

Report to N.S.W. Police for Sydney Hobart Yacht Race Coroner's  
Inquiry

**Tony Boyle**

*Faculty of Maritime Transport & Engineering  
Australian Maritime College, Launceston, Tasmania.*

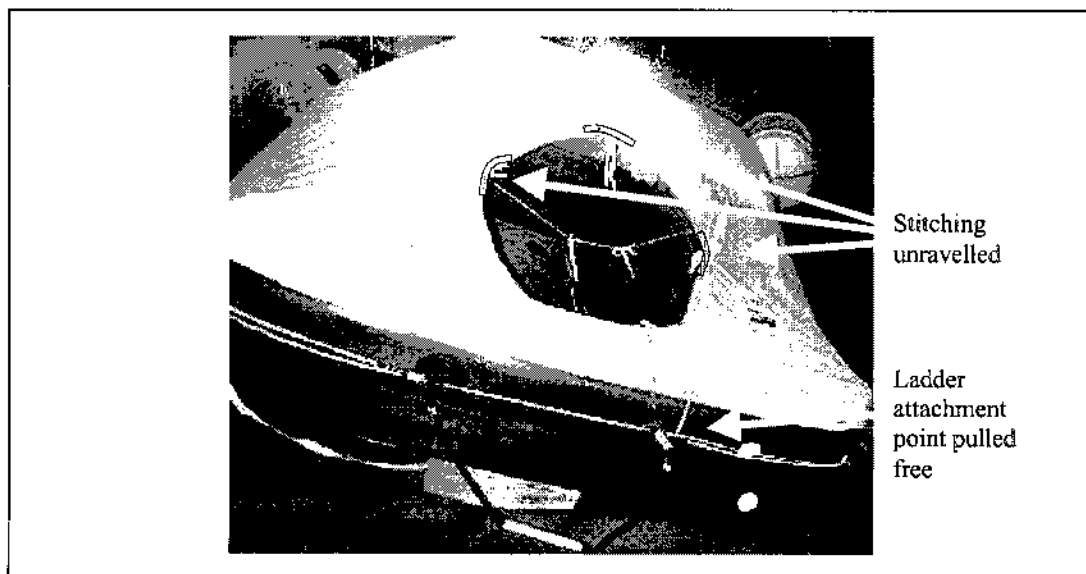
Figure 2.1  
Areas of canopy and ladder damage

During the conduct of trials the buoyancy and canopy support tubes remained intact and at full working pressure. Damage sustained to the raft during these activities consisted of:

- o Damaged stitching adjacent to the canopy entrance hold back ties for a distance of 3-5 cm either side of each tie (see Figure 2.1).
- o Separated stitching for a distance of about 4 cm at the lookout port point of attachment to the canopy.
- o Righting strap attachment point on the corner to the left-hand side of the canopy entrance (Figure 2.2) separated from the liferaft. This occurred during righting trials with more than the recommended number of persons remaining inside the raft. No such problem was experienced with the Petrel or SOLAS 6-person rafts during similar trials.
- o The left hand boarding ladder attachment point (Figure 2.1) separated from the liferaft. This resulted from righting activities after the main righting attachment point parted, placing the righting line load on the boarding ladder strong point.
- o The canopy became detached from the canopy support arch.

All damage was repaired prior to the conduct of the 'at sea' trials.

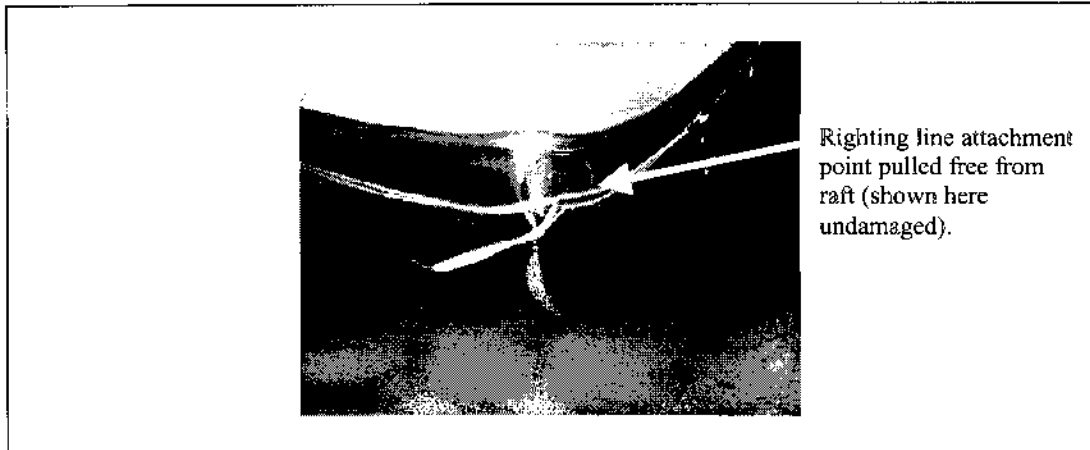
Figure 2.2  
Strong point damage

During conduct of the sea trials it was observed that the Pro Saver liferaft floor and canopy were much less resistant to damage than those of a 6-person Petrel liferaft. These observations are fully described in Section 4 of this report.

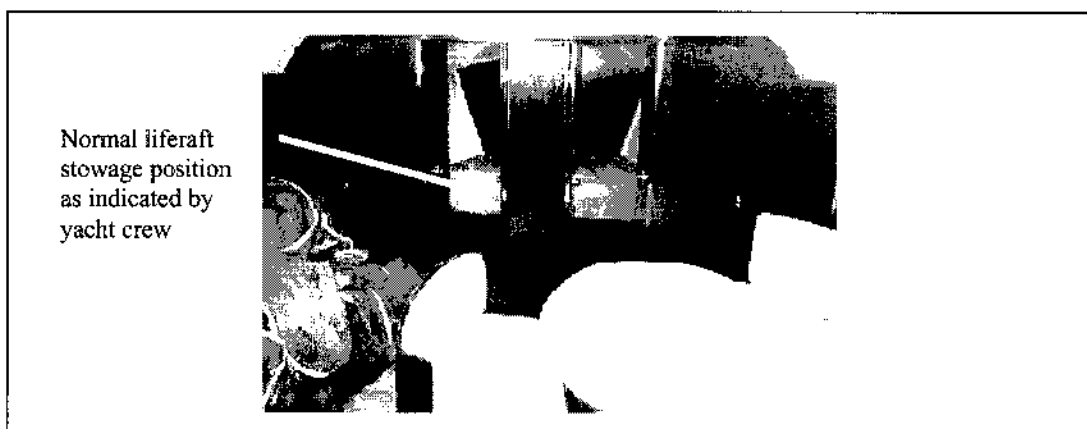
The survey also received 8 responses reporting that the liferafts stowed below deck were not stowed in a position adjacent to the companionway in accordance with the *Racing Rules of Sailing*. Figures 3.2 and 3.3 show examples of this situation.

Figure 3.2  
Liferafts stowed several metres from companionway

Figure 3.3  
Liferaft stowage position several metres from companionway

1. Where liferafts are stowed below deck Rule 4.19 (a) iii of the *Racing Rules of Sailing* should be enforced with respect to location adjacent to the companionway and security of stowage.
2. Liferafts stowed below deck should be securely lashed into position.
3. Liferafts stowed on deck should use a lashing system that is robust. Lines used for lashings should be inspected for deterioration on a regular basis.
4. Yacht crews should receive on board familiarisation training relating to the lashing and release system and used for each raft carried on a vessel.
5. On board training for crew members at accessing and moving a liferaft stowed below deck to a launching position should be encouraged.

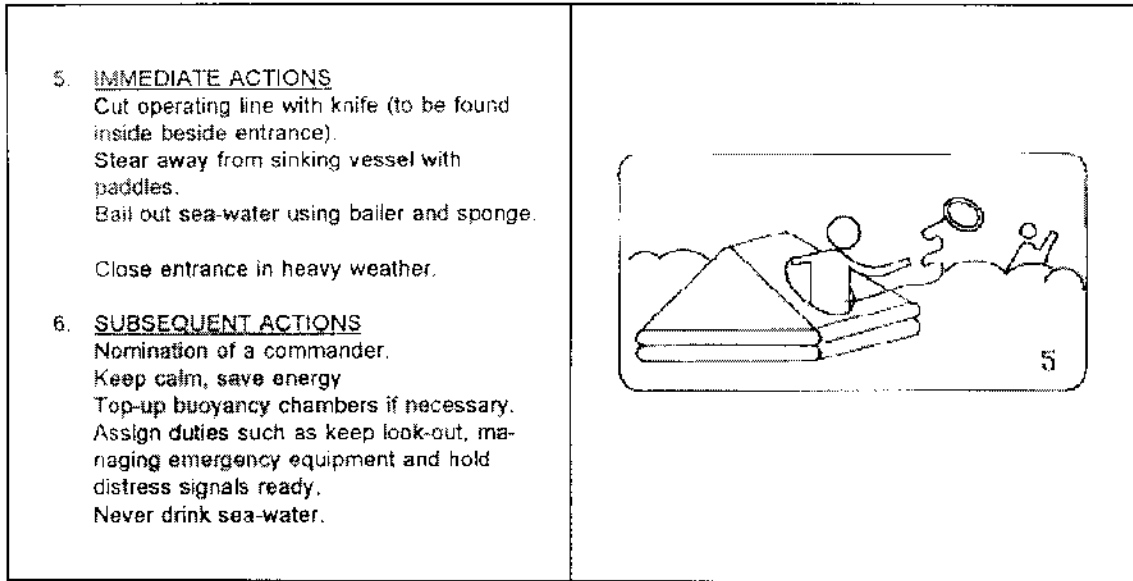
Figure 4.2  
 Immediate action instructions from Pro Saver liferaft

The ‘immediate actions for survival’ instructions contained in the Pro Saver Liferaft were found to be located inside the equipment pack. These were printed on waterproof plastic sheets located in a plastic sheath and identified by the heading “Important Documents”. Extracts from these instructions are shown in Figure 4.2.

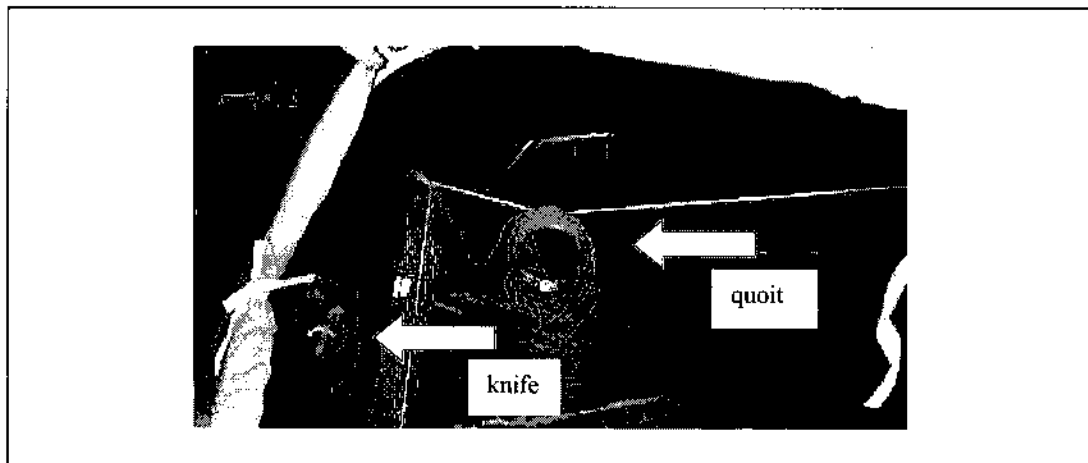
Figure 4.4  
Location of some internal fittings in the Pro Saver

Liferaft fittings such as a knife and rescue quoit and line are normally located inside a liferaft, attached by a lanyard which prevents accidental loss. These items are sometimes identified by the use of pictorial signs so that they are less likely to be overlooked by the raft occupants during the first critical moments after boarding. The Pro Saver liferaft was found to contain pictorial instructions for operation of inflation points stencilled to the inside of the buoyancy tubes, but did not use any means of identifying the knife or quoit and line, apart from the instructions for immediate action contained in the liferaft manual (Figure 4.2). However, as Figure 4.4 shows, the location of these fittings would make them difficult to overlook, provided the occupants knew to look for them.

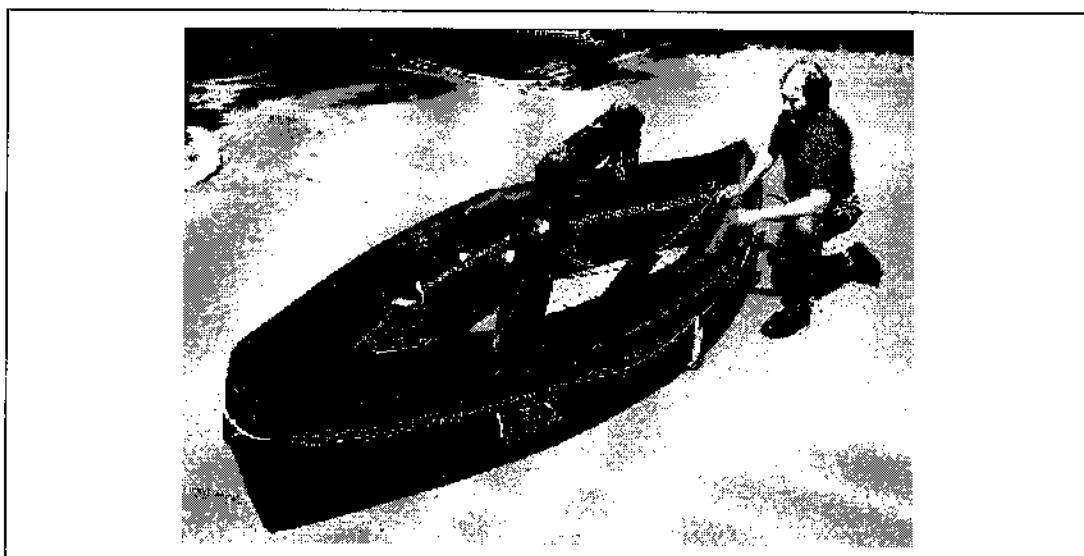
Figure 4.15  
Shape of Pro Saver raft with floor and canopy removed

4. The shape adopted by the buoyancy tubes of a liferaft once the floor and canopy were removed did not prove to be a contributing factor to the ease of maintaining contact with the raft during practical trials. Liferaft occupants observed that it was extremely difficult to maintain contact with the Petrel and the Pro Saver liferafts when they were hit by a breaking wave. This is supported by the video footage recorded during the liferaft sea trials.

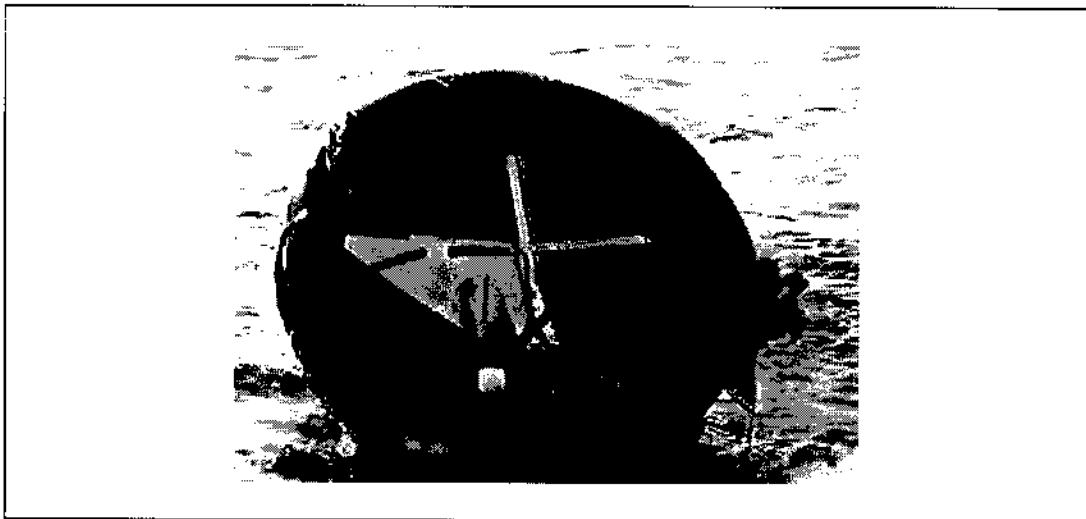
Figure 4.16  
Effect of an incision in the Petrel liferaft floor

The experiment was then repeated using an RFD 6-person Petrel liferaft which had been condemned 3 days prior to the trial. In this case the floor was observed to be more resistant to tearing from the incision. It took considerably more stamping to initiate spreading, but once started extended across the raft at about the same rate as that in the Pro Saver. However, the final extent of floor damage was much less than that experienced with the Pro Saver. In this instance, half of the floor remained intact as is shown in Figure 4.16. The raft then was inverted to facilitate video footage and then re-boarded in this position.

The Petrel liferaft canopy was observed to display a significantly higher resistance to damage than the Pro Saver liferaft. The raft occupants were unsuccessful in initiating a deliberate tear in the canopy by stamping and jumping in the inverted raft. The canopy and remainder of the floor were subsequently cut away using a knife. *Van Diemen* then made three close passes at 30 knots to determine the effect of a breaking wave on the shape of the raft. The raft remained its original circular shape but the occupants were easily washed from the raft on two occasions as it tumbled in the wave.
