SPECIAL REPORT : SR99/004

Research and Development test of yachting safety products

Client : NSW Police Service
NSW Water Police Branch,
Wharf 25
Harris Street
PYRMONT NSW 2009.

One (1) Yachting line involved in fatal incident,
from the 'Sword of Orion' yacht.

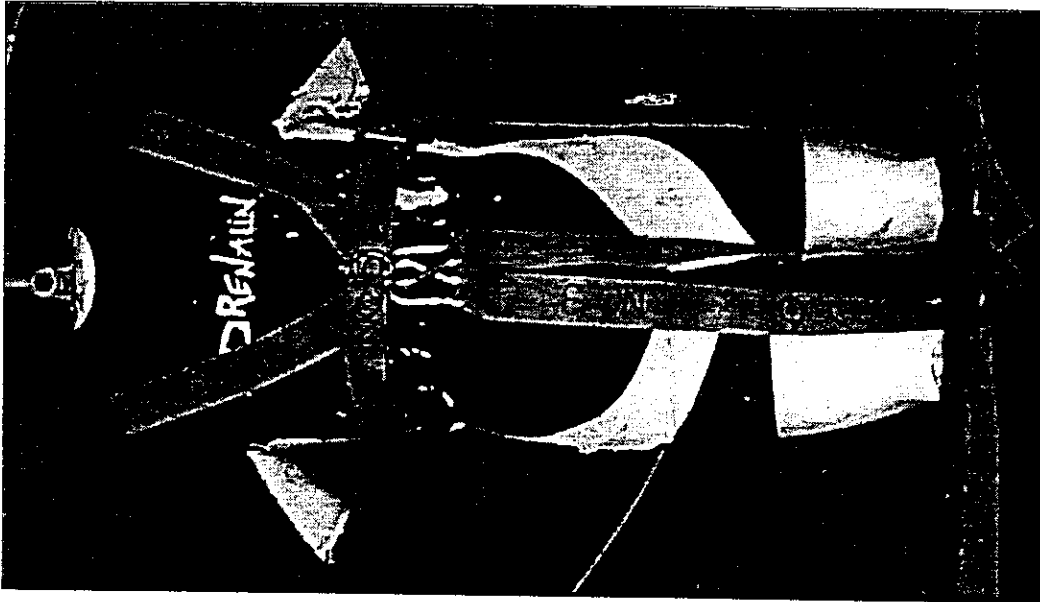
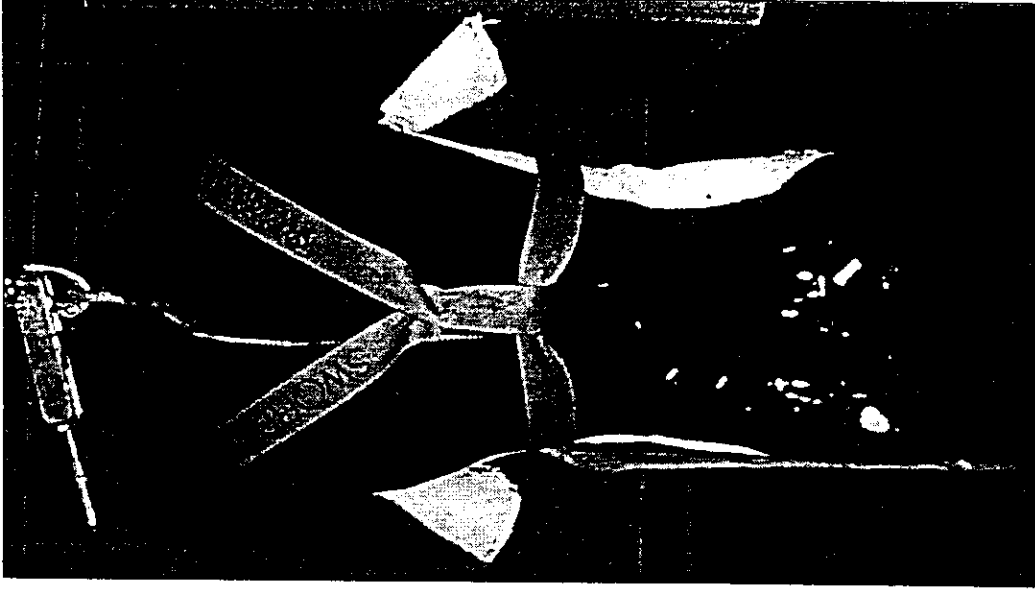
The complete yachting harness and line assembly supplied from the 'Sword of Orion' yacht, was tested to the dynamic test requirements of Appendix B of AS 2227:1992. Refer to Photographs 2 and 3 in Appendix B.

Photographs 2 & 3 - Yachting harness and line assembly supplied for the comparative test program.

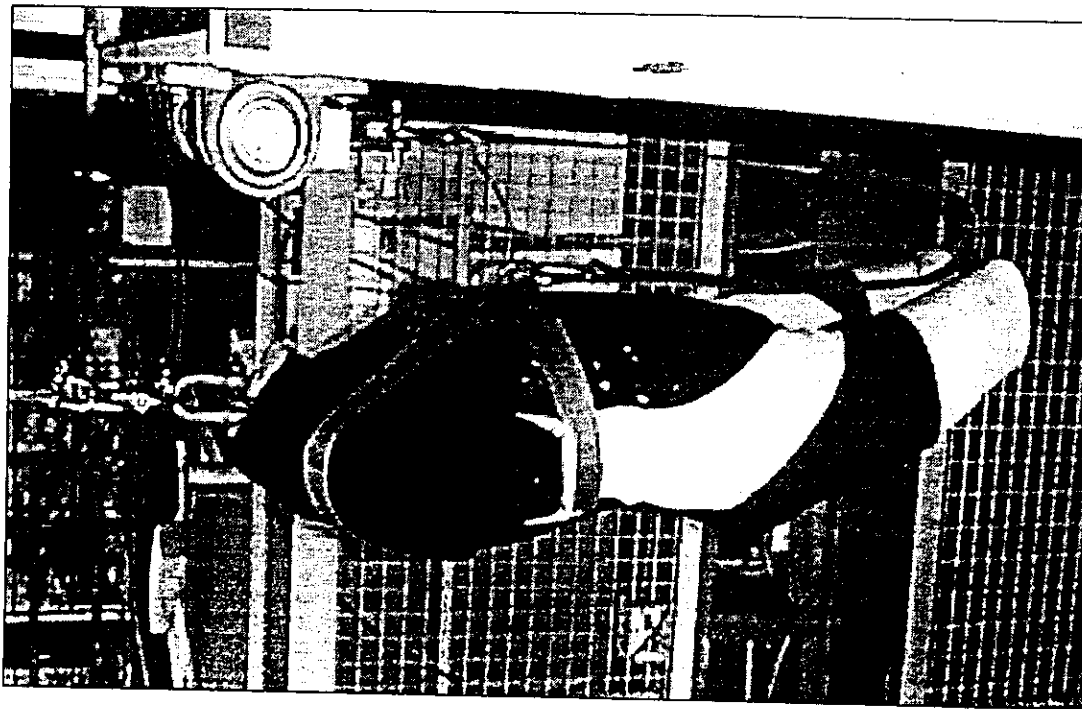
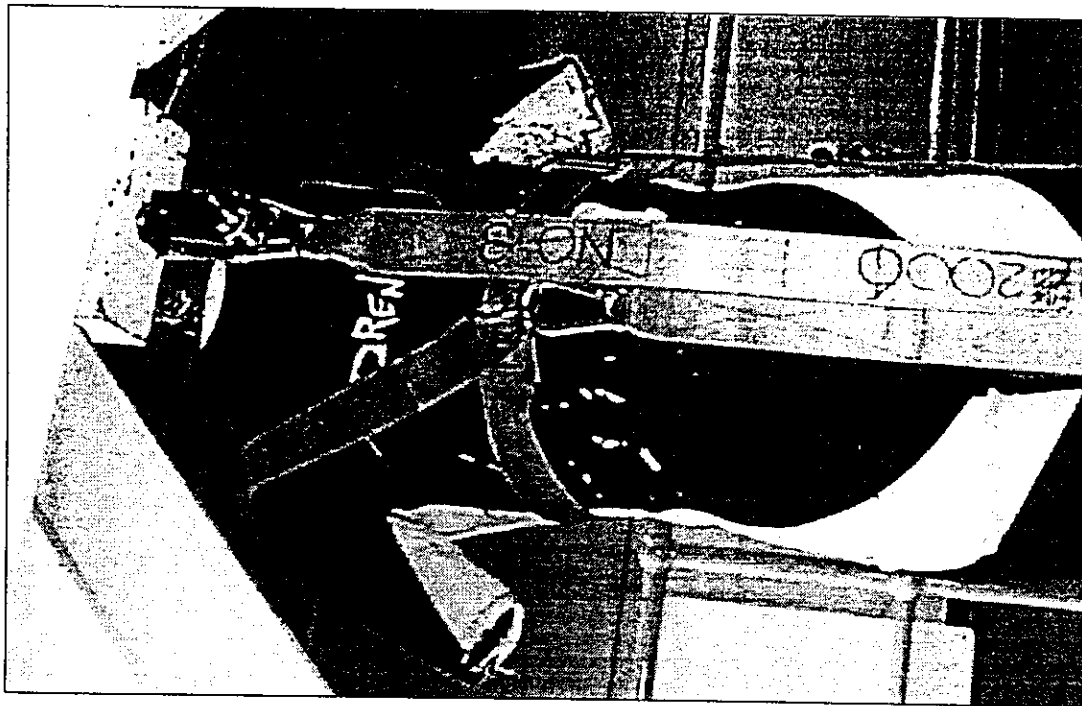
The yachting line was then attached to the front 'O' ring attachment point of the harness and to the rigid anchorage point of the harness drop tower. The dummy was raised in an upright position and held via a quick release device until released to fall through the appropriate dropping distance of 1.47 m. Refer to Photographs 6 and 7 in Appendix B.

Photographs 6 & 7 - Pre test view of yachting line connected to harness attachment point and harness drop tower anchorage point.

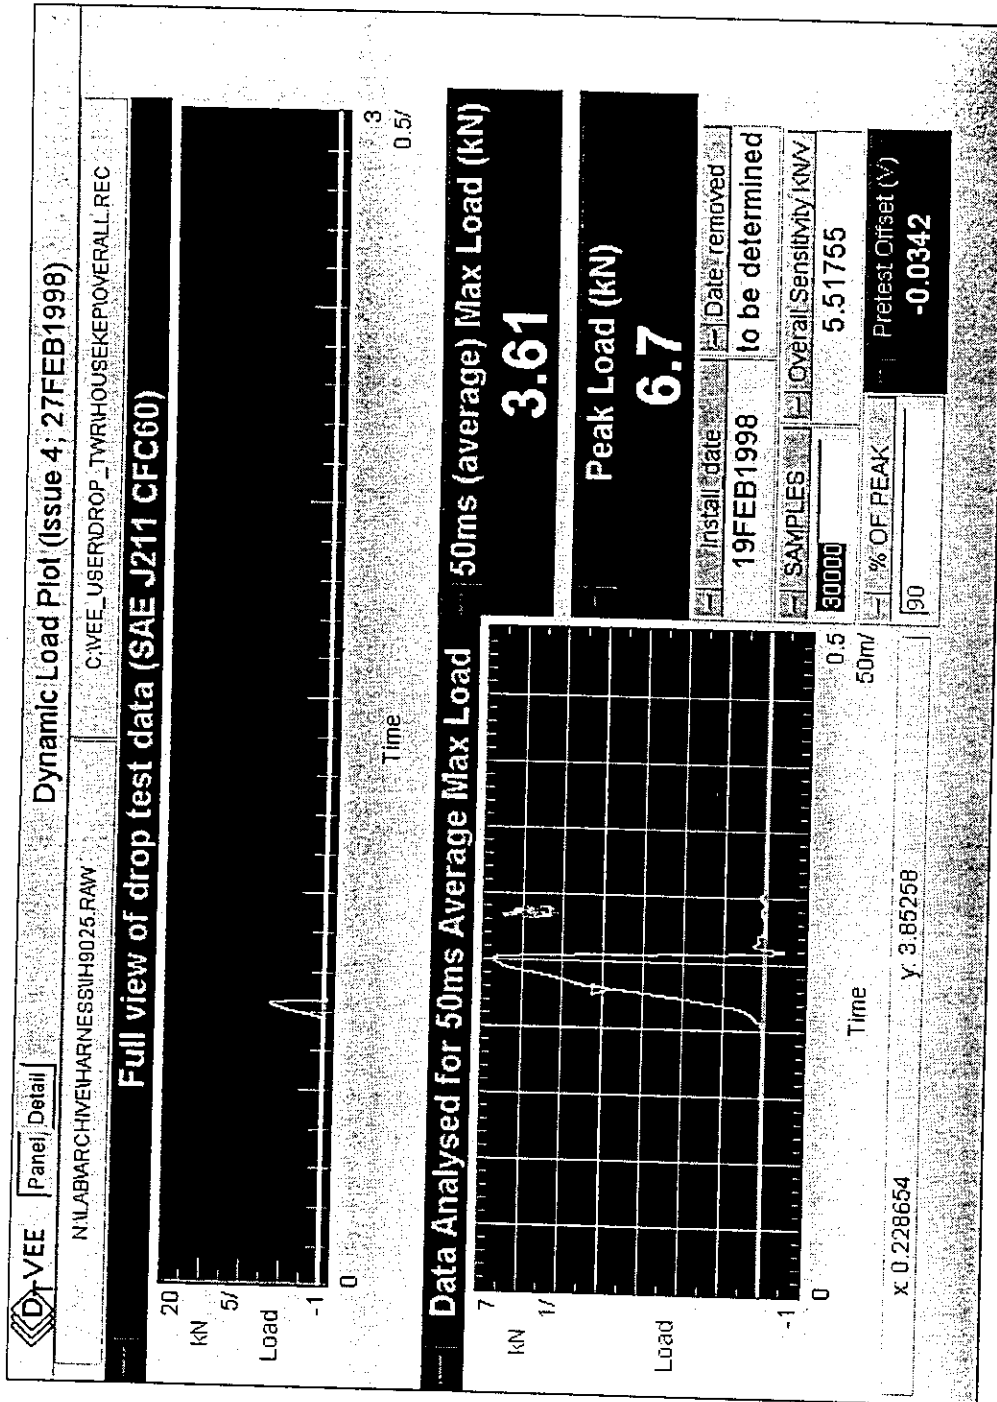
APPENDIX C - TEST RUN NUMBER IH9025 PRINT OUT

Post test examination of the Test Run Number IH9025 on the complete yachting harness and line assembly revealed that the anchorage attachment end stitch pattern failed completely at 6.7 kN. The test dummy was not retained and only the hook was left at the harness anchorage point. Refer to Photograph 8 in Appendix B.

Test Number	Specimen Numbers (Harness / line)	Attachment Point	Mass of Dummy (kg)	Drop Height	Movement at Adjustable Point (mm)	Peak Load (kN)	Dummy shall be retained in the harness	Any Failure and / or Deformation
IH9025	TS16757 / TS16758	Frontal 'O' ring	136	1.47	Inconclusive	6.7	Fail	Fail
