# Issues Relating to Liferaft Operation

Report to N.S.W. Police for Sydney Hobart Yacht Race Coroner's  
Inquiry

**Tony Boyle**

*Faculty of Maritime Transport & Engineering  
Australian Maritime College, Launceston, Tasmania.*

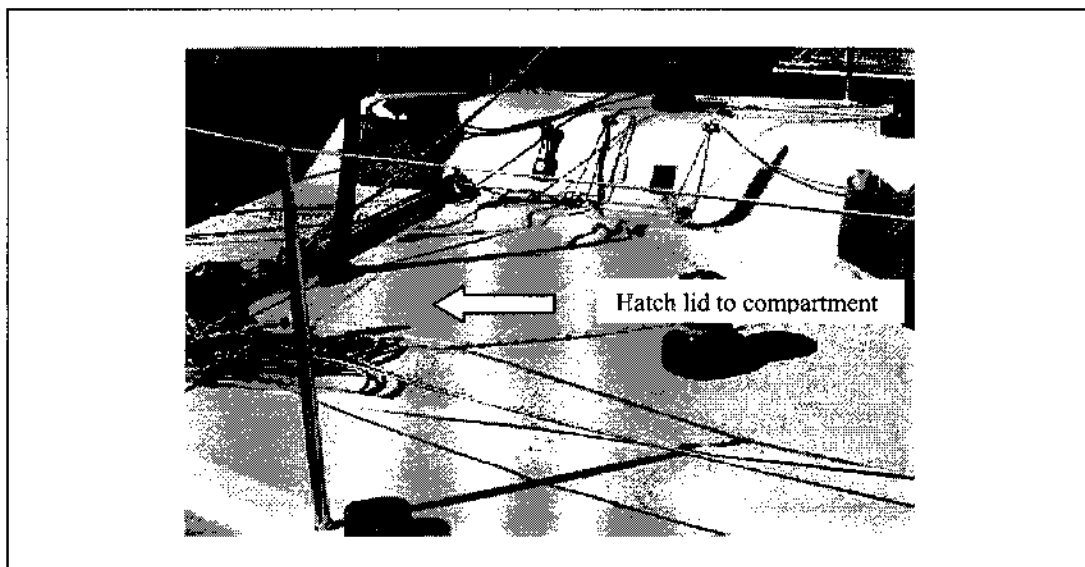
Figure 3.1  
Purpose built liferaft stowage compartment

Note: Seven of the rafts included in the on deck category are stowed in a compartment in the cockpit deck and are accessed via a hatch as shown in Figure 3.1.

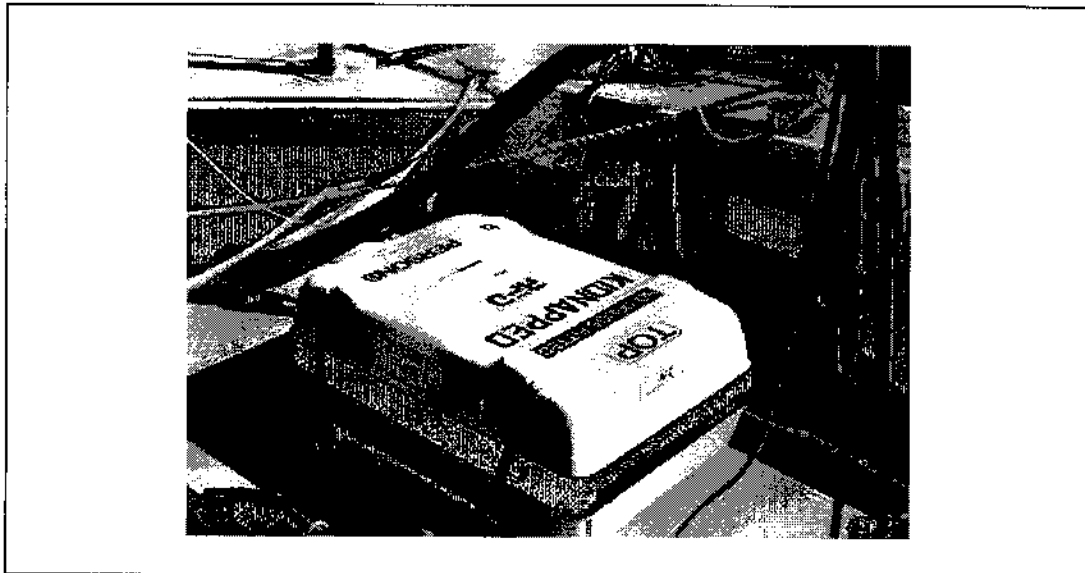
Figure 3.5  
Cockpit stowage under tiller

- 52% of vessels surveyed used a direct lashing that must be untied or cut with a sharp knife to release the liferaft (Figure 3.5).
- 34% of vessels surveyed used a lashing secured via a quick release mechanism such as a senhouse slip (Figure 3.6).
- 3 % of vessels used webbing lashing straps that are manually slipped off the raft to release it.
- 3 % of vessels relied on the hatch securing mechanism associated with on deck stowage in a purpose built compartment (Figure 3.1).
- The remaining vessels reported either wedging the raft into position below deck (2 vessels) or leaving the rafts loose below deck (2 vessels).

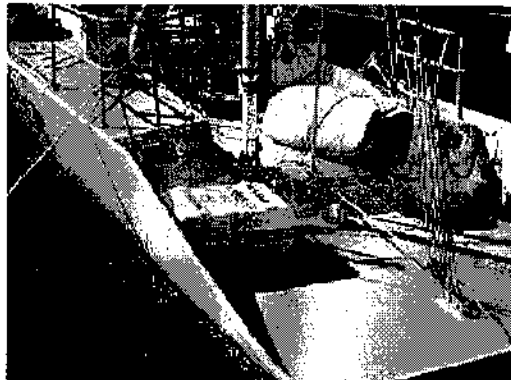
Figure 3.7  
Transom stowage

The justifications provided for this method of stowage (Table 3.6) show that the on deck position is seen to have the advantages of the raft being easy to launch and not needing to be lifted to a launching position. However, on deck stowage has the potential for:

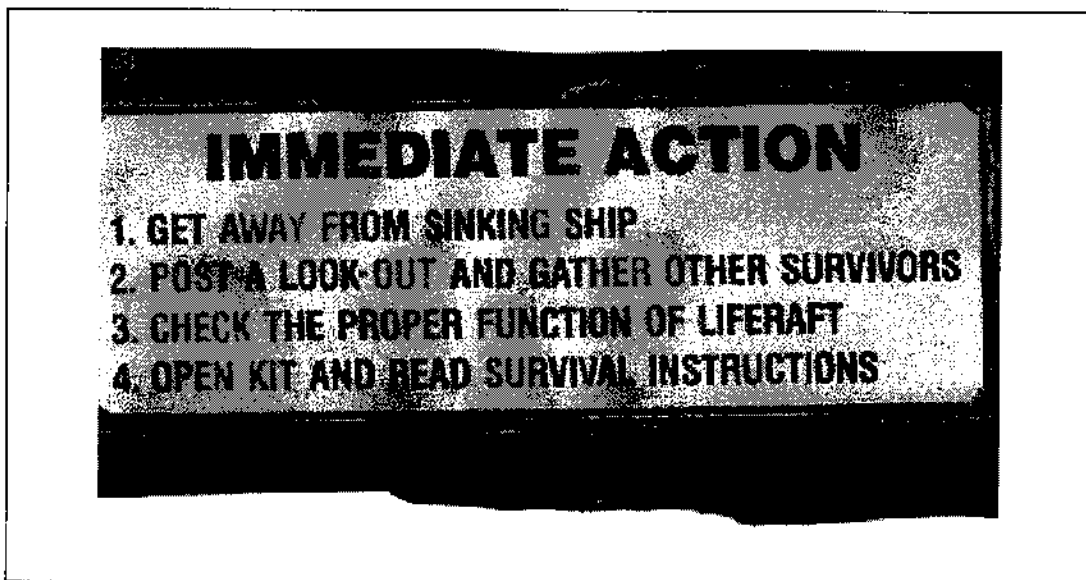
Figure 4.3  
 Immediate action instructions from ME Petrel liferaft

Figure 4.3 shows the ‘immediate action’ instructions that were located on the floor of the ME Petrel 6-person liferaft used in the ‘at sea’ trials.

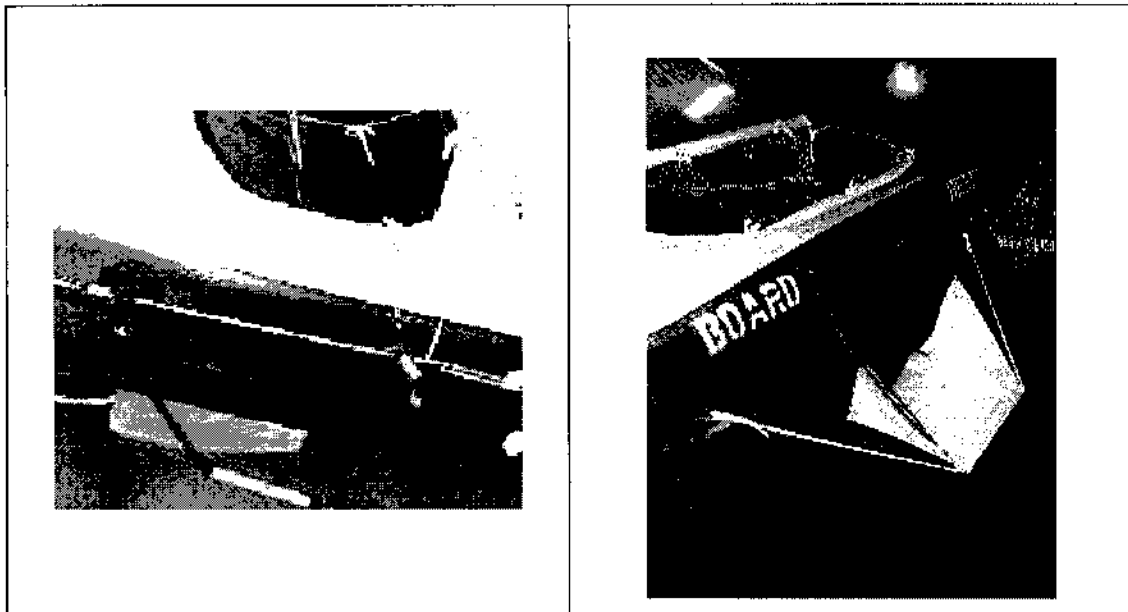
Figure 4.6  
Boarding ladder

*"The problem with getting into the raft was that the sides of the raft were quite high physically for me to get into and I was impeded by the life jacket which had a large area on the chest...."*

There are two boarding systems currently used on inflatable liferafts; boarding ladder as shown in Figures 4.6, and a boarding step or semi-rigid ramp as shown in figure 4.7.

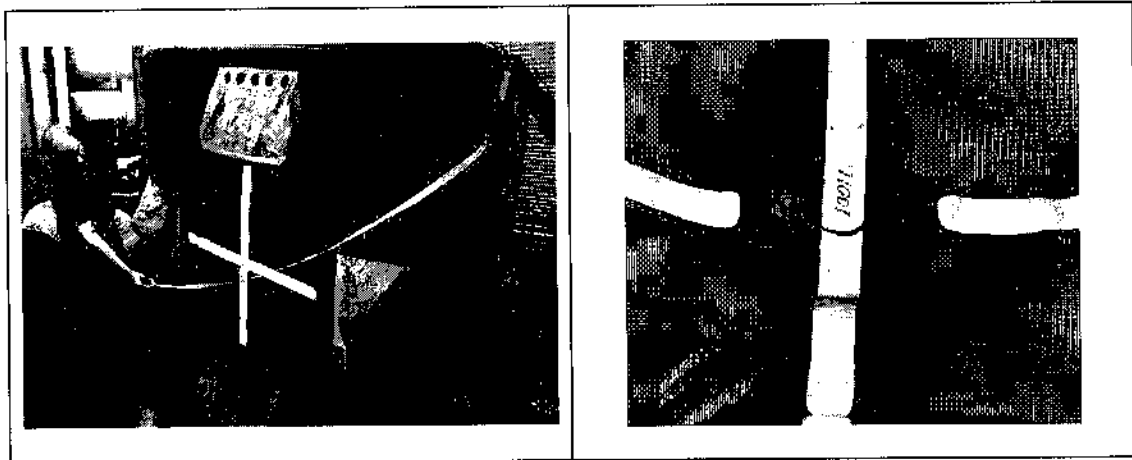
Figure 4.8  
Righting strap

The Pro Saver liferaft used for trials was fitted with a webbing righting strap which runs diagonally across the outside of the liferaft floor as shown in Figure 4.8. Instructions for righting the Pro Saver liferaft were found located in the instructions for survival located inside the equipment pack. These included pictorial instructions as shown in figures 4.10.
